4 WTC 4, 5, and 6

4.1 Design and Construction Features

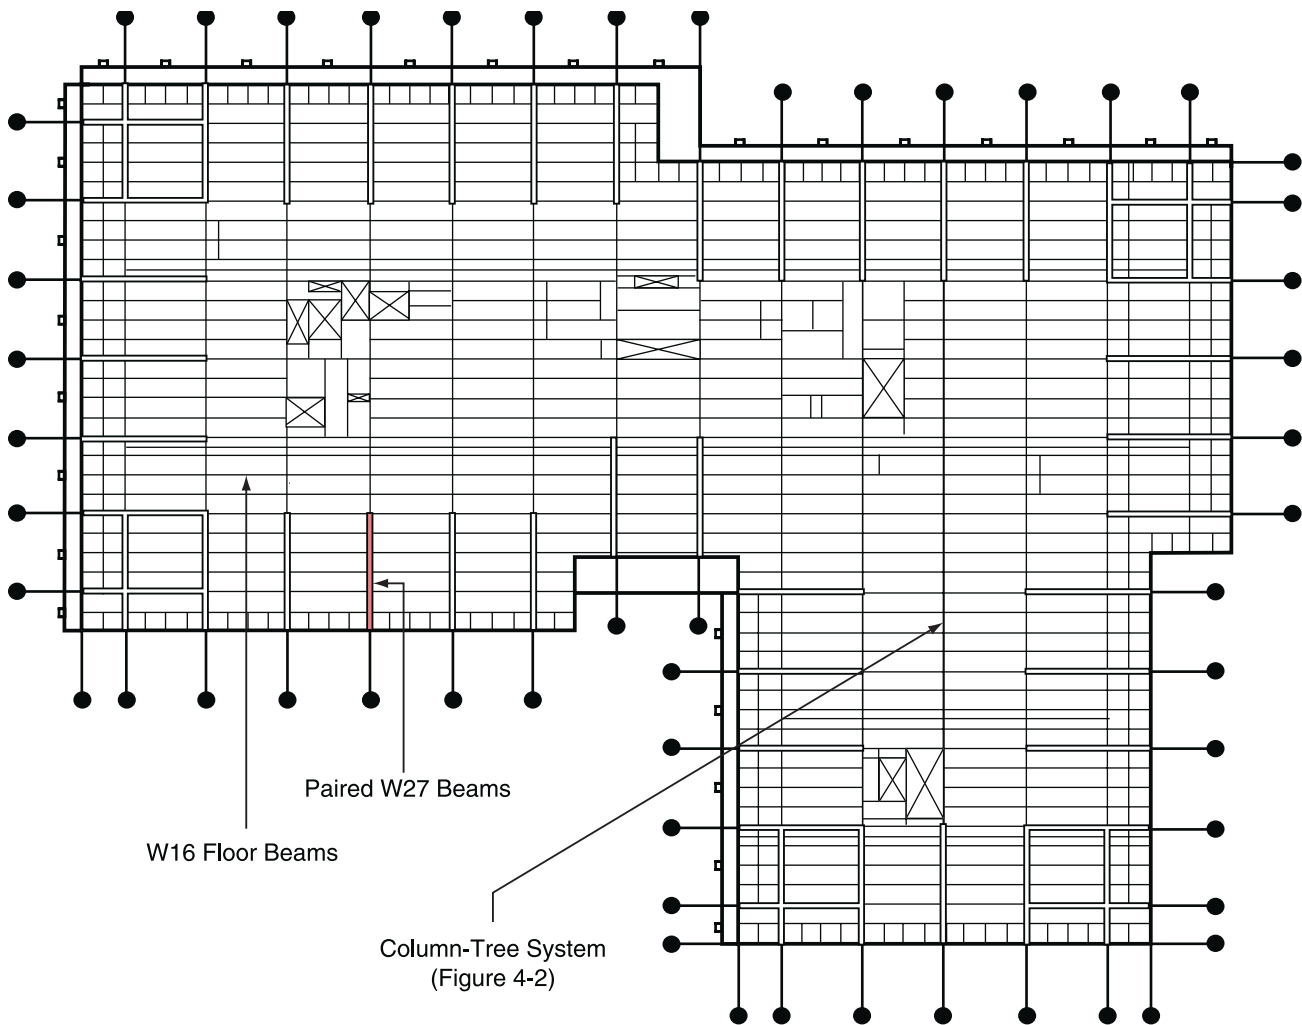
Figure 4-1 Typical floor plan for WTC 5 (Worthington, Skilling, Helle & Jackson 1968).

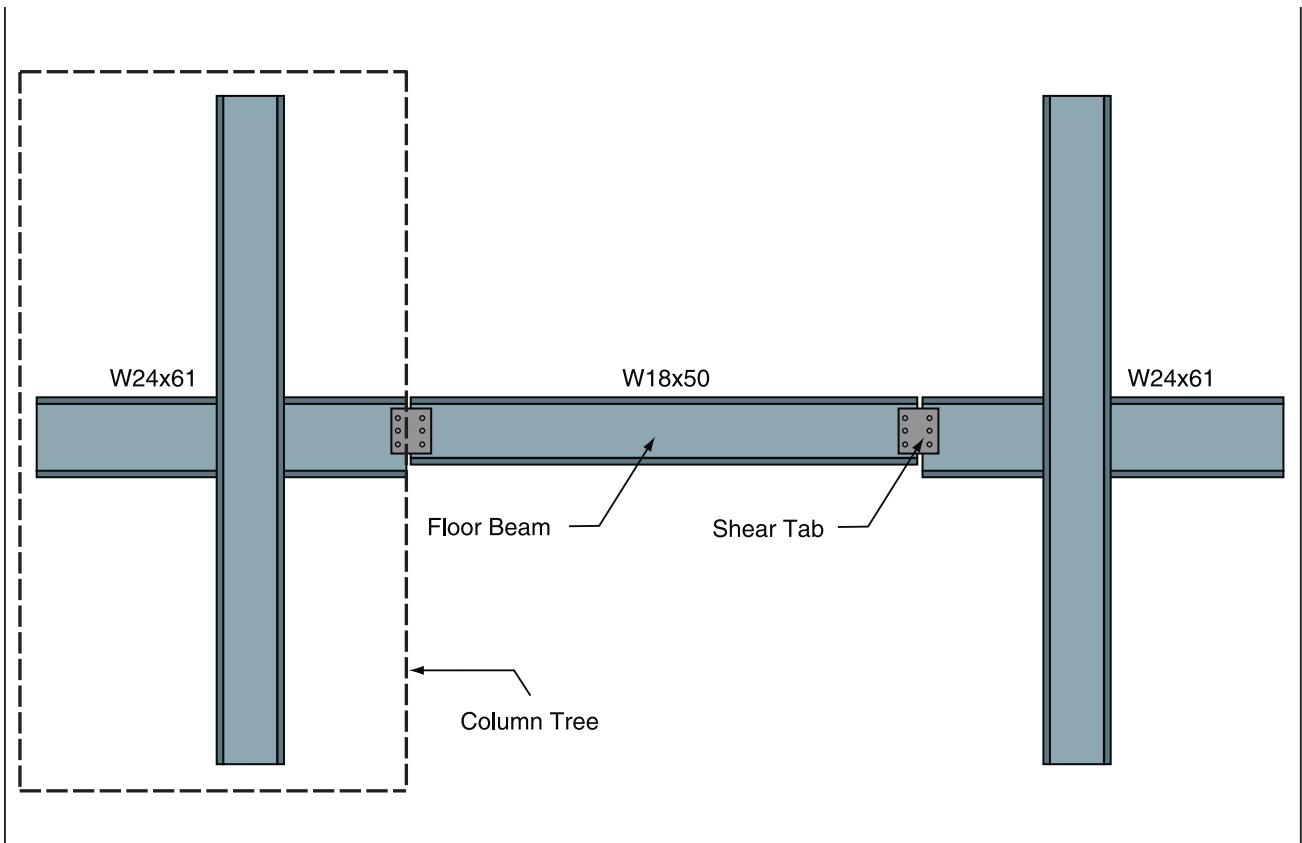
simply connected, with shear tabs, to the cantilevers (Figure 4-2). Floor 9 and roof level framing was conventional for steel-frame construction and did not include a column-tree system, as illustrated in Figure 4-3.

Figure 4-2 Typical column-tree system (not to scale).

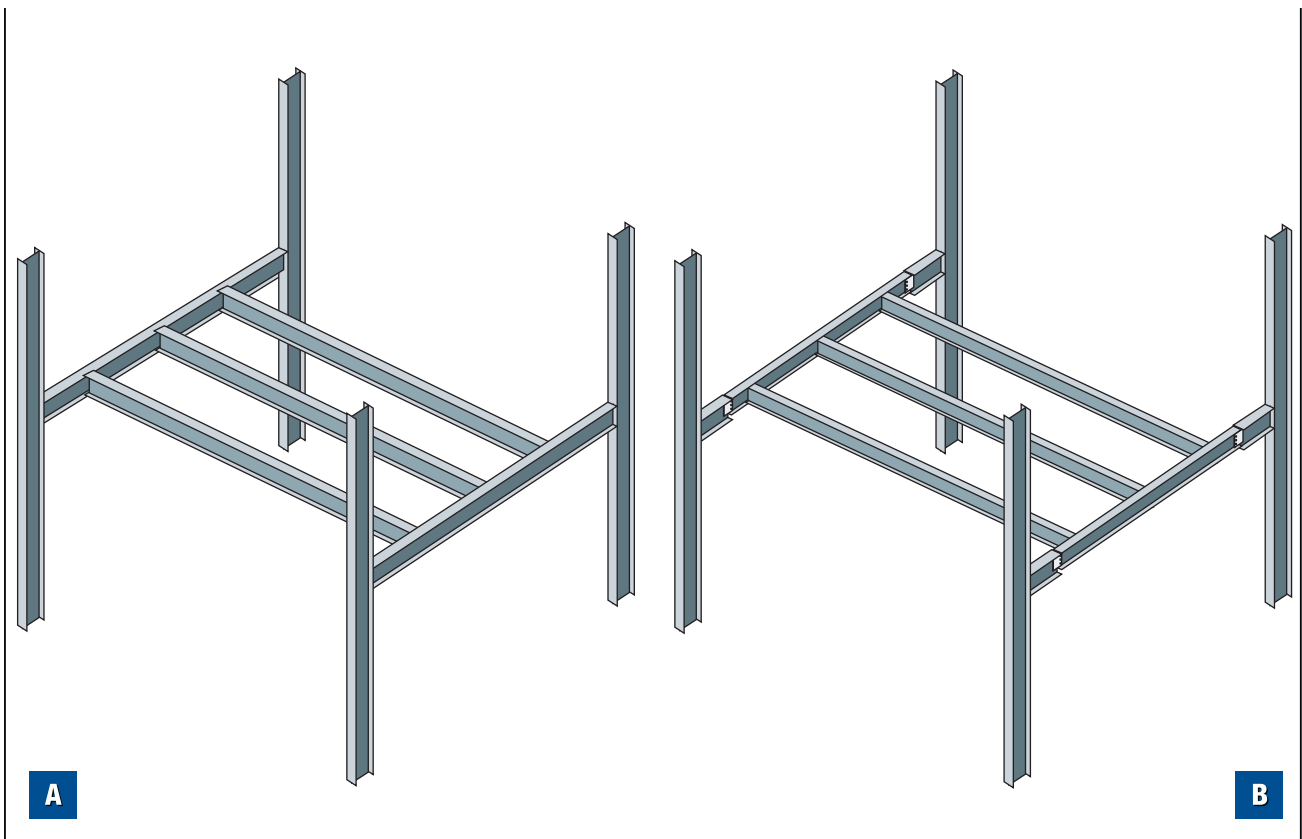
Figure 4-3 Typical interior bay framing in WTC 5. (A) Floor 9 and roof level. (B) Floors 4, 5, 6, 7, and 8.

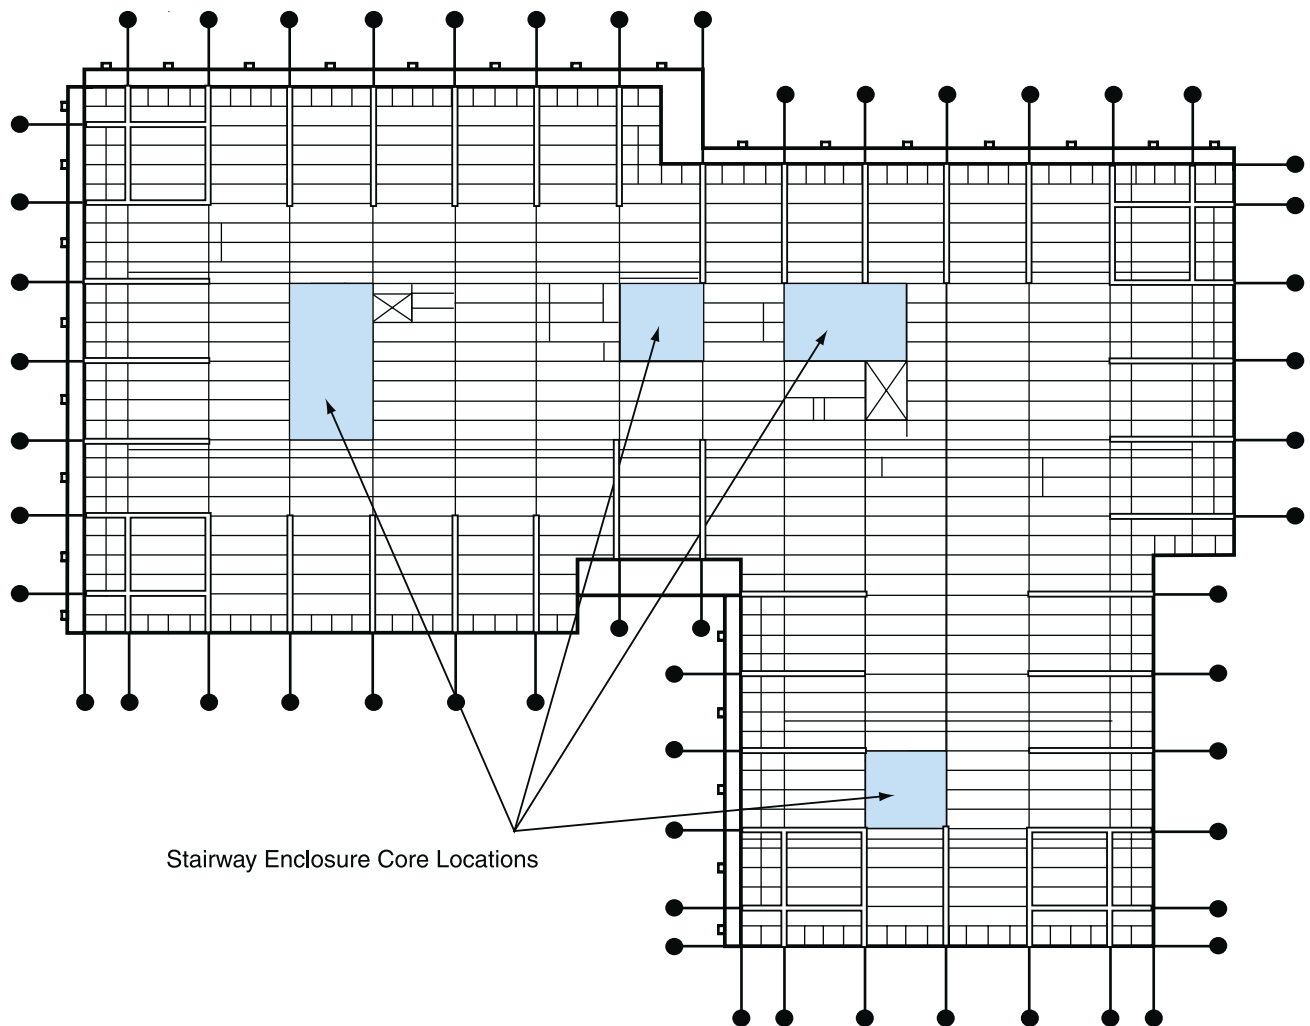
The stairway enclosure core areas were constructed of two layers of 5/8-inch-thick Type-X (fire resistant) gypsum wallboard on both sides of steel studs. The elevator shafts were constructed of HT shaped steel studs and gypsum wallboard and coreboard, which provides a 2-hour fire resistance rating. This type of wall framing permits construction of elevator shafts from the office side of the wall. These core areas are illustrated in Figure 4-4.

Figure 4-4 Stairway enclosure core locations in WTC 5.
